## 2005 FINAL PROJECT REPORT

### Microbial Source Tracking And Virginia's Beach Monitoring Program

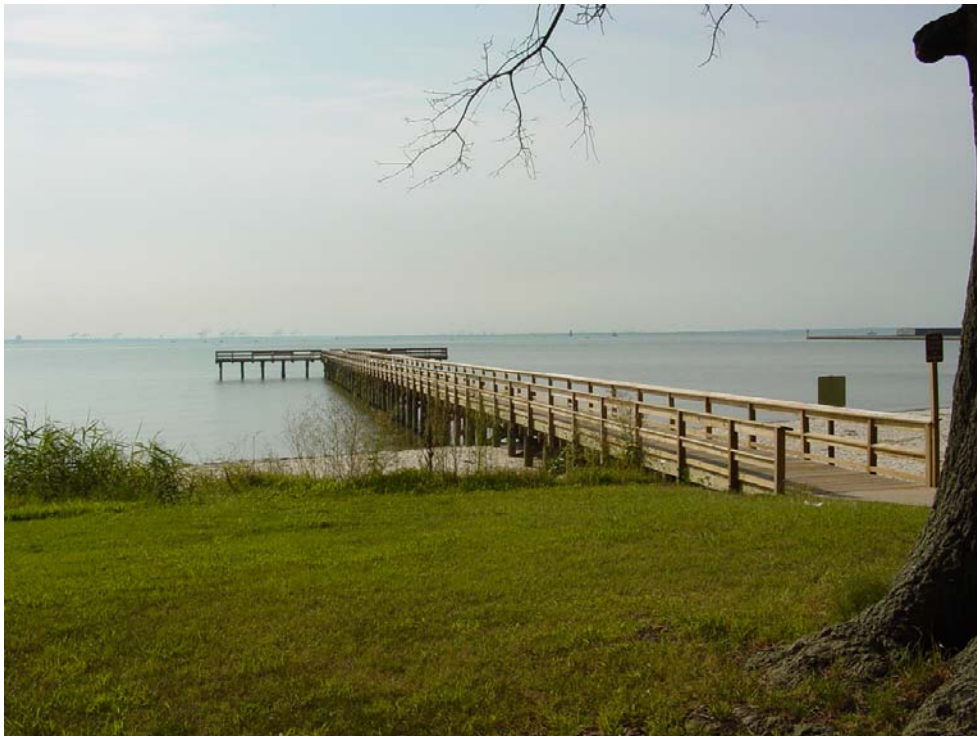
The new fishing pier built at King-Lincoln Park in early 2005. Structures like piers attract birds, especially when trash is dumped on the end of the pier. Trash receptacles are needed at this beach.

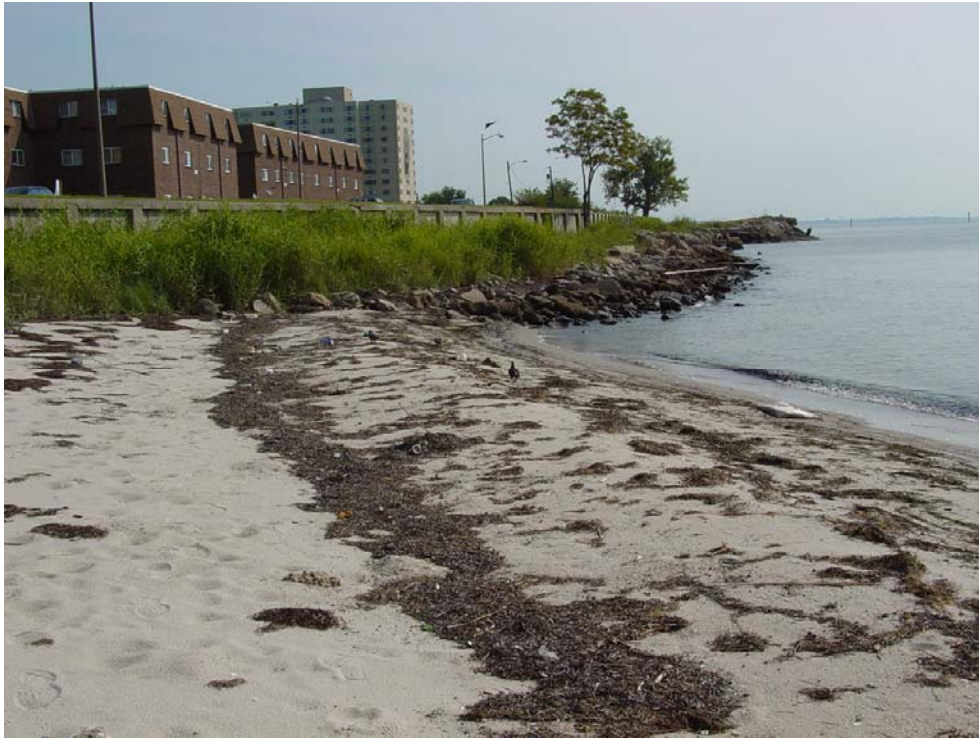
Northern part of the beach area between the pier and the apartments. The beach was often littered with trash, including soiled diapers and dog wastes. The storm drain is out of sight to the left.

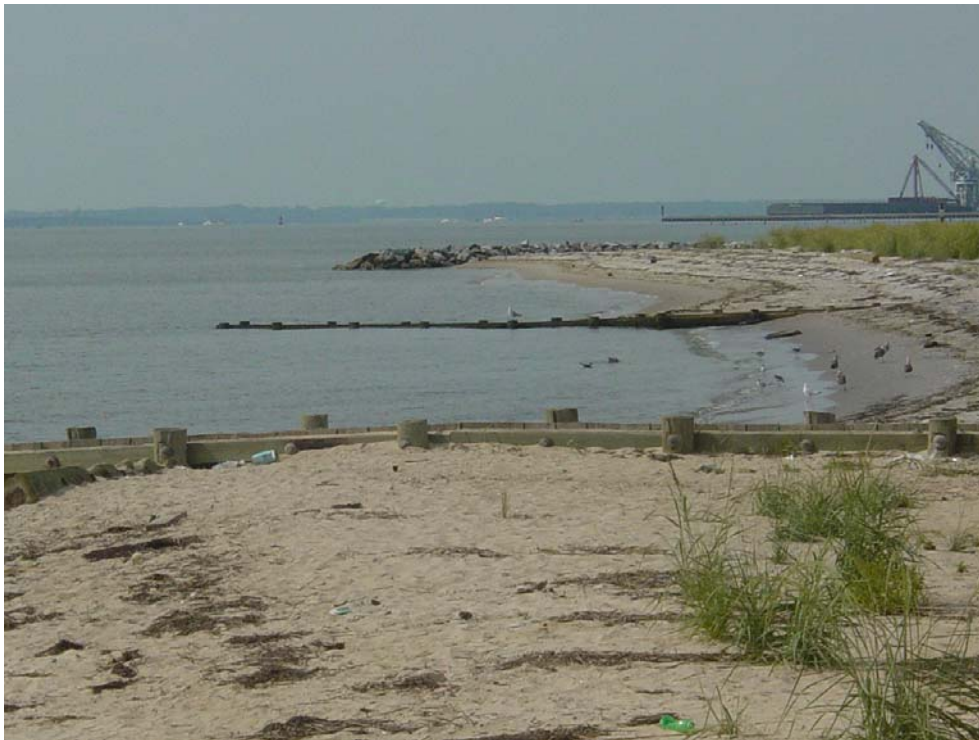
Image 1. Anderson A sampling site location, in between the first and second jetties in the picture. Trash receptacles are needed here. The view is looking south, and the storm drain is out of site to the north of where the picture was taken.

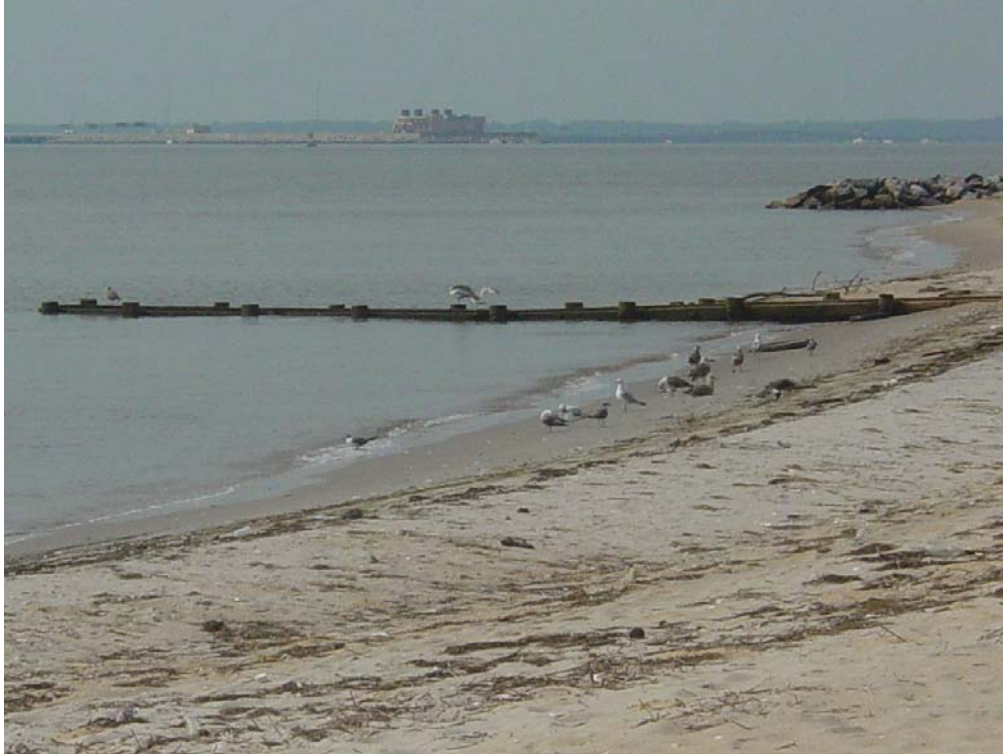
Image 2. Anderson B sampling site location, in between the jetty and the rock breakwater in the picture. The view is looking south, and Anderson A is out of site to the north of where the picture was taken.

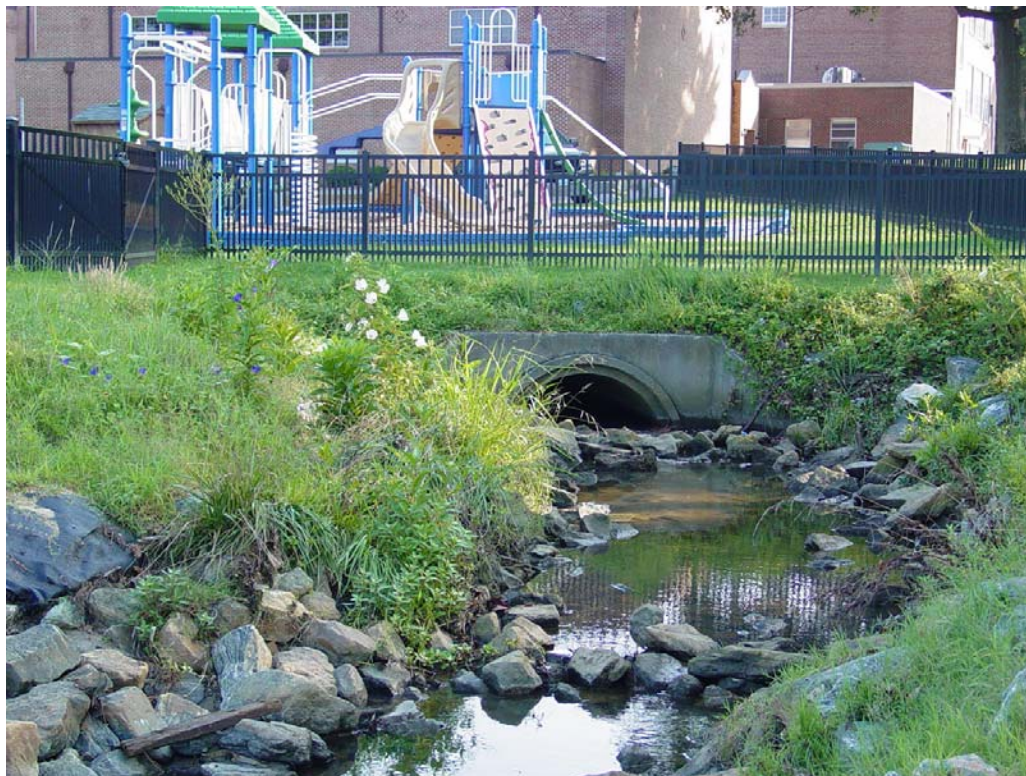
Image 1. The storm drain outfall on the eastern end of Hilton Beach.

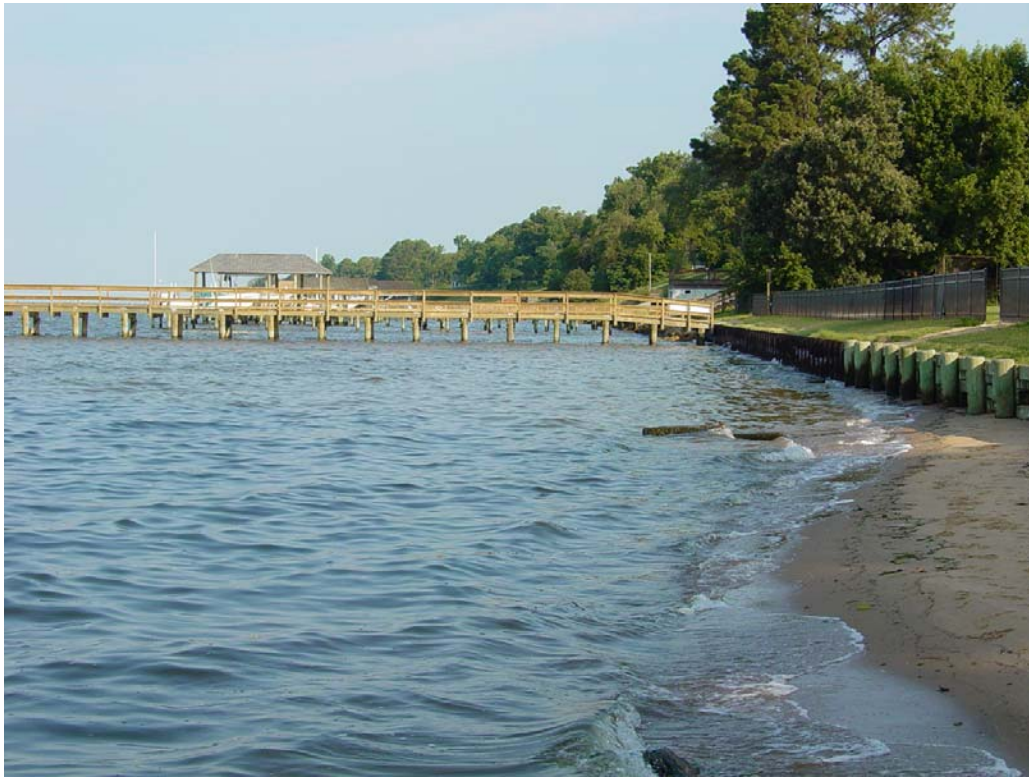
Image 2. Hilton Beach at high tide, when very little of the beach is above water. The storm drain is out of sight to the right, the new fishing pier is on the western end of the beach.

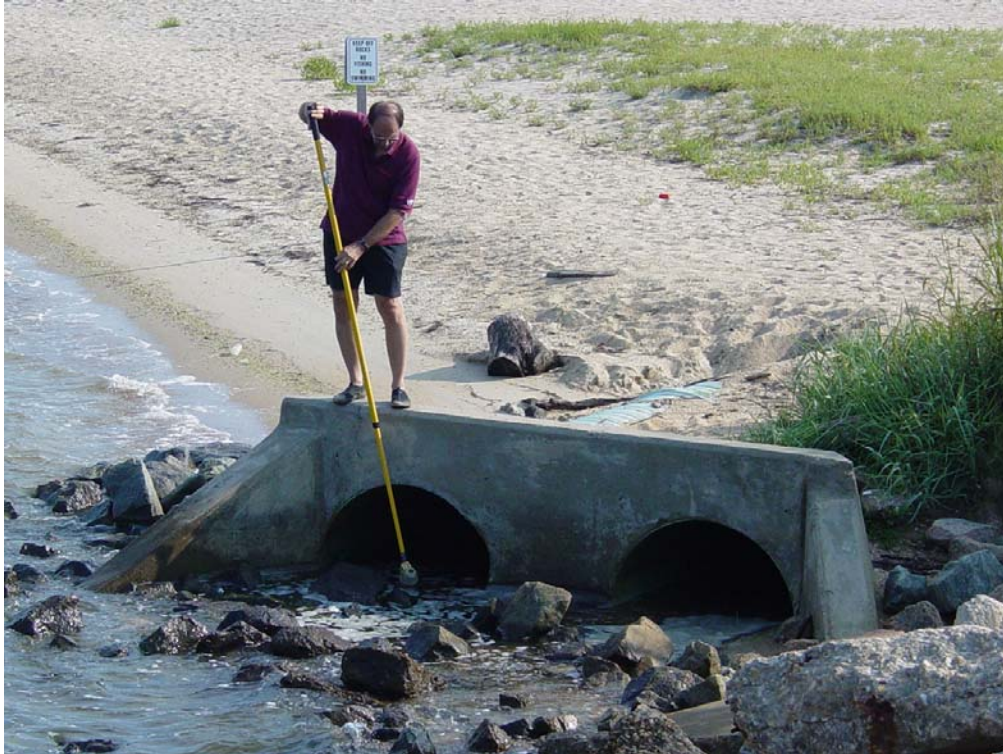
Image 1. The beach is bordered on the east by the James River Bridge, and the picture shows a large storm drain that is on the eastern end of the beach, next to the bridge causeway.

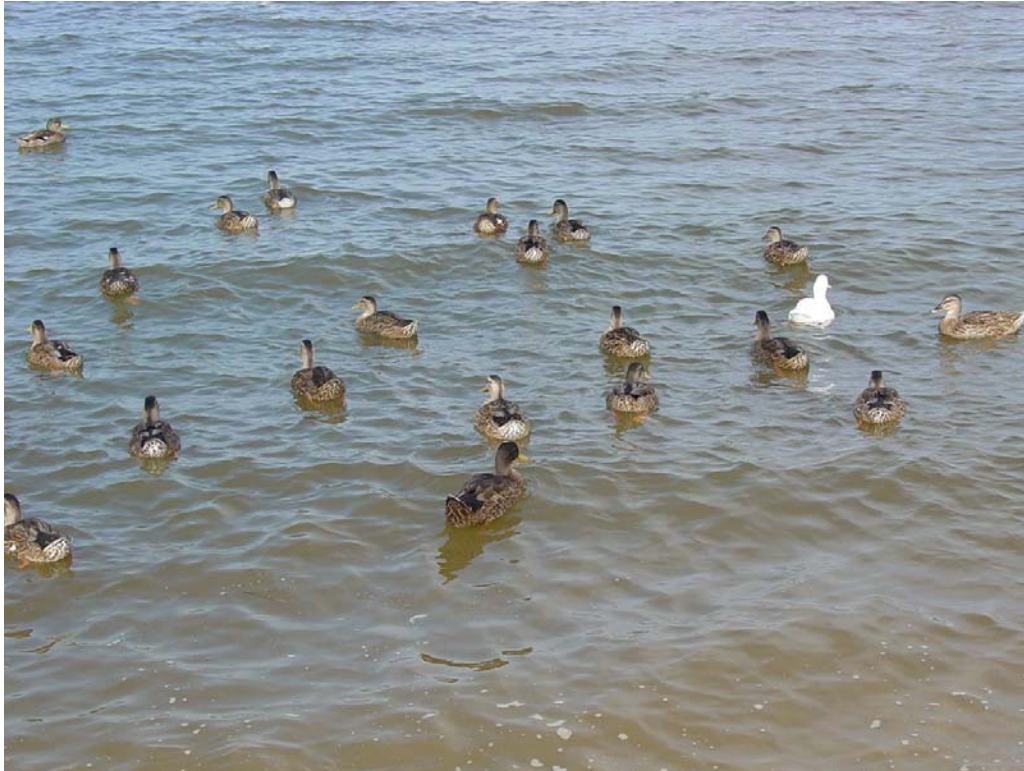
Image 2. Marsh ducks and Herring Gulls in the designated swimming area at Huntington Beach.

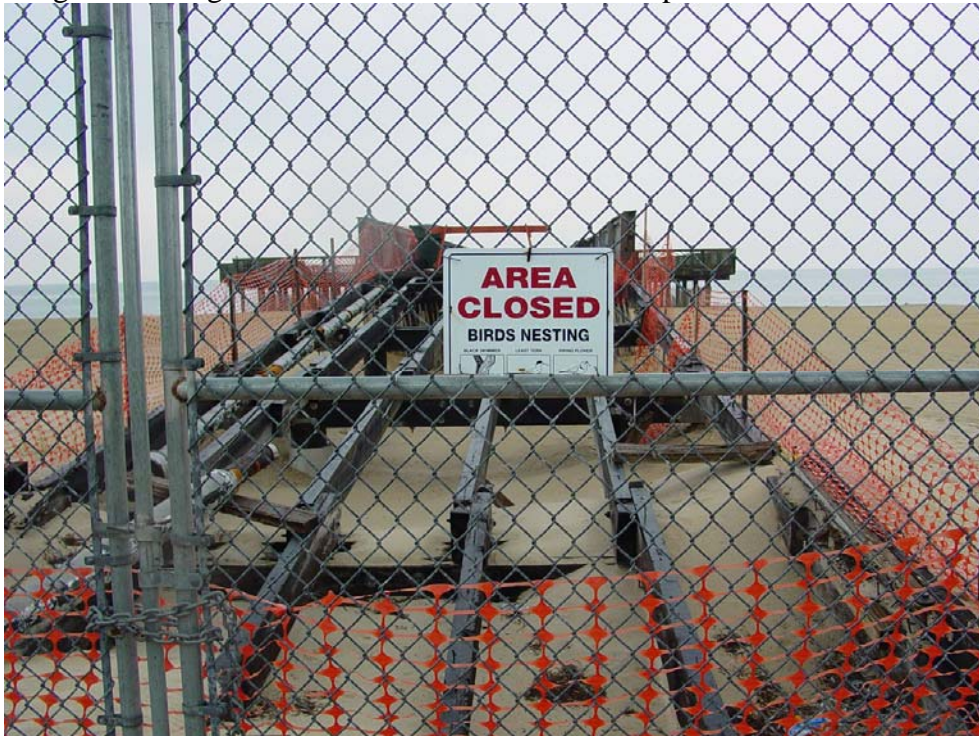
Image 4. Nesting birds halted reconstruction of the pier in summer of 2005.

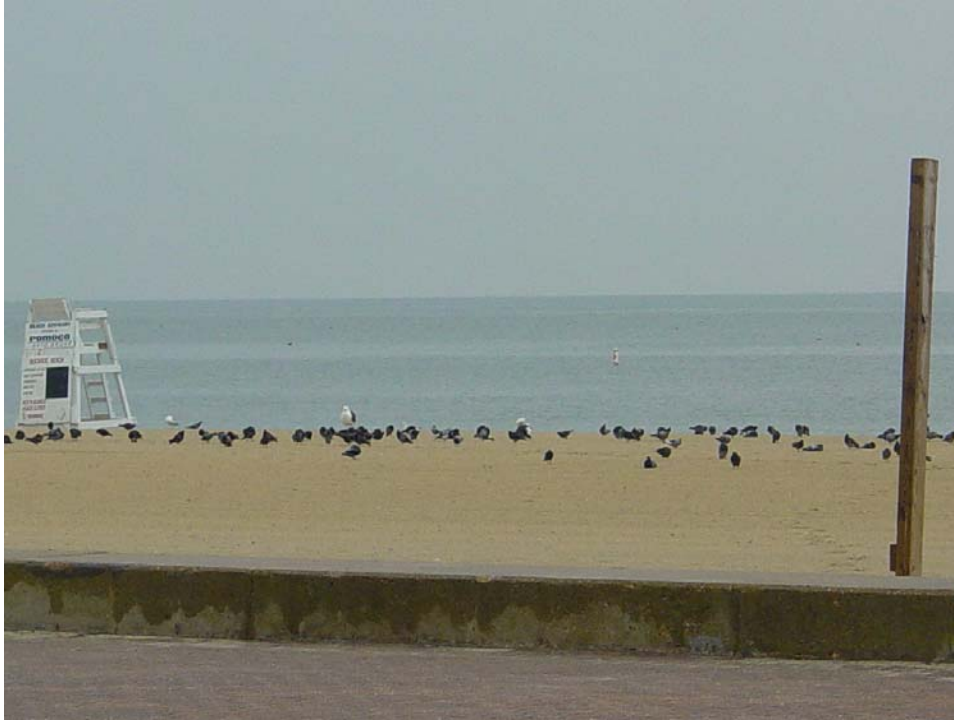
Image 5. Birds on the beach, early morning, August 2005.

The above image shows the large numbers of shore and nuisance birds (pigeons) that appear to permanently reside in the area and are often seen on the beach when few people are around. The lack of swimming advisories demonstrates the effectiveness of the rebuilt beach in acting as a sand filter and removing microorganisms that might otherwise end up in the water.

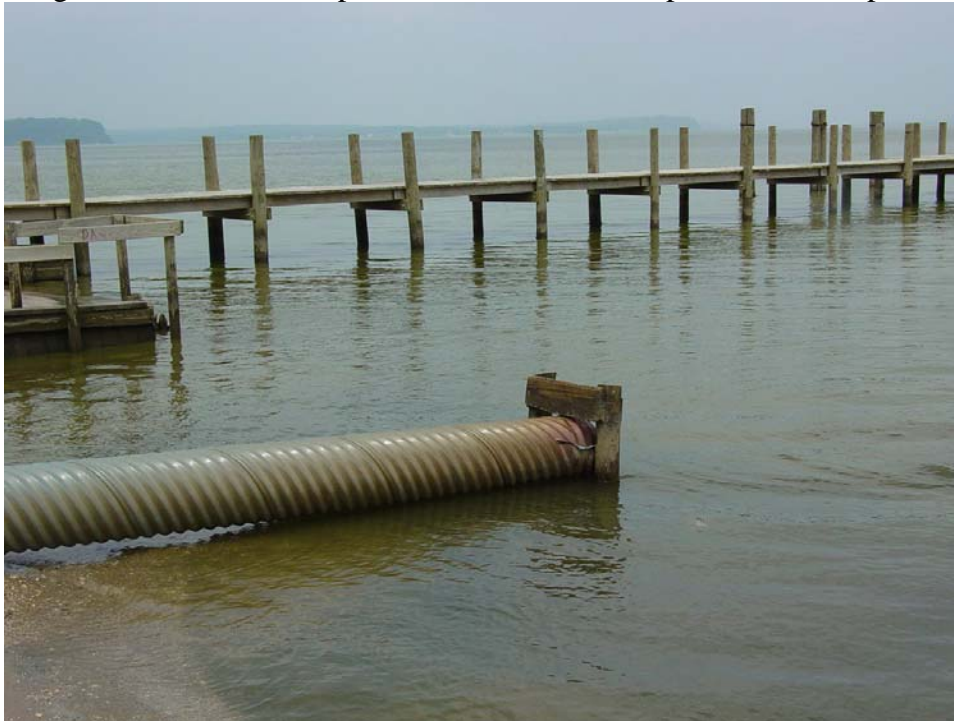
Image 2. Storm drain and pier at 8<sup>th</sup> Street, where a public boat ramp is located.

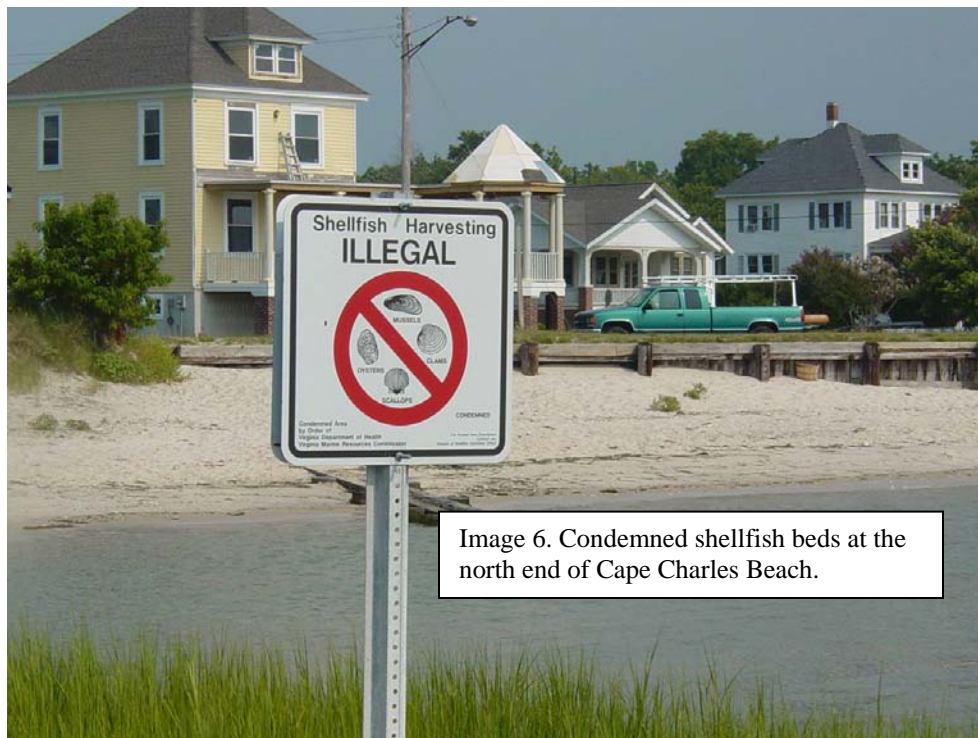
In addition, VDH-DSS samples shellfish monitoring stations that start at the north end of the beach and extend into Cherrystone Inlet. There are shellfish beds in the area around the north end of the beach where the storm drains are located, and these beds are closed to harvest due to fecal pollution (see following picture). This demonstrates that the storm drains are having an impact on water quality in the immediate area where they are located, but have not been a concern further away in the swimming areas up to this point (plus, the regulatory standard for shellfish harvest is much lower than for contact recreation, so it is very feasible to have waters where shellfish harvest is prohibited but swimming is not). Drainage from the storm pipes could be much more of an issue in the swimming areas during a wet summer where larger amounts of contaminated water would be discharged just a short distance north of the beach.

Image 6. Condemned shellfish beds at the north end of Cape Charles Beach.
